# Fire safety of battery powered autonomous ferry: a case study of Sundbåten using System-Theoretic Process Analysis.

**University of South-Eastern Norway** Faculty of Technology, Natural Sciences and Maritime Sciences

**MASTER THESIS**

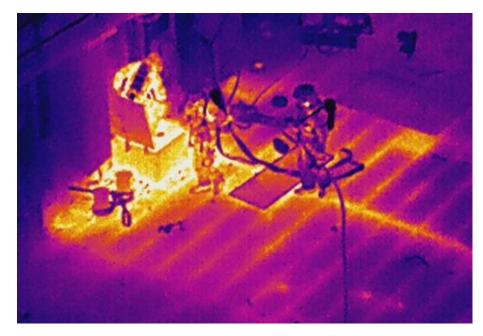
Figure 10 – "Infrared drone image of the battery room hatchet". VIB. Retreived from: Vest brann- og redningsregion, 2019, p. 10).

After some time, the fire department agreed that it was time to attempt to gain control. The smoke diver team prepared a normal hose and a drone with IR camera to monitor the situation from above (see figure 10). At 12:21 the hatchet leading to the battery room were measured to be 20-30°C. The infrared camera showed clear signs of heat surrounding the hatchet, but there were uncertain if the heat was from steam or other gasses. To clarify if there were hydrofluoric acid in the area, gas measurements were done both above and below deck but there were no findings at that time. At 13:26 fluoric acid was detected near the battery hatchet. One meter down the hatchet, 2 ppm were measured. At 14:07 a new measurement was done in the bottom of the battery room at 10 ppm. The battery room itself had major damage and the highest temperature were measured to be 70°C. At 15:34 divers were pulled out.
