CONCISE REPORT

Can the use of assistive technology and interactive therapeutic robots in nursing homes contribute to the spread of infectious disease?

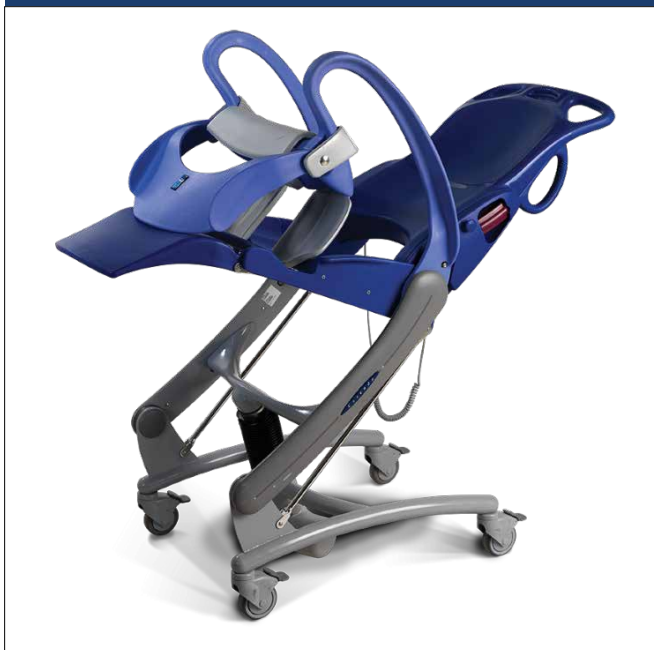
Multipurpose hygiene chairs are used for washing and cleaning routines that require assistance from nursing staff (Figure 1).

FIGURE 1: Multipurpose hygiene chair Carendo, ArjoHuntleigh [from: <http://www.arjohuntleigh.com/products/hygiene-systems/showering/shower-chairs/carendo/>]

Four hygiene chairs (Carendo, ArjoHuntleigh, Sweden), two in each nursing home, were labeled according to the following scheme NxCx (N for nursing home 1 or 2, C for chair 1 or 2). N1C1 was not in use, due to necessary maintenance, but served as reference. N2C2 had been used by one resident only. N1C2 and N2C1 were in use by more than one resident, and no special precautions other than visible cleaning have been done. All hygiene chairs were visible clean according to applied standards [3] before sampling.

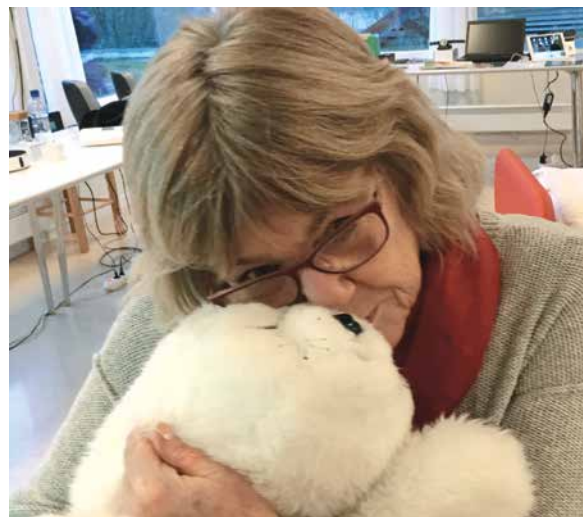
PARO robots (Figure 2) are used in dementia care [2] to stimulate patients and cleaning done by the nursing home staff can only be done in a superficial way. Washing the interactive robot is not possible so that the artificial fur needs to be replaced by the distributor.

FIGURE 2: PARO interactive therapeutic robot in close contact with resident

Four PARO robots, two in each nursing home, labeled NxPx (N for nursing home 1 or 2, P for robot 1 or 2). N1P1 and N1P2 were in sporadic use during the sampling period. For all PARO robots, there was no cleaning performed between the use by different residents.

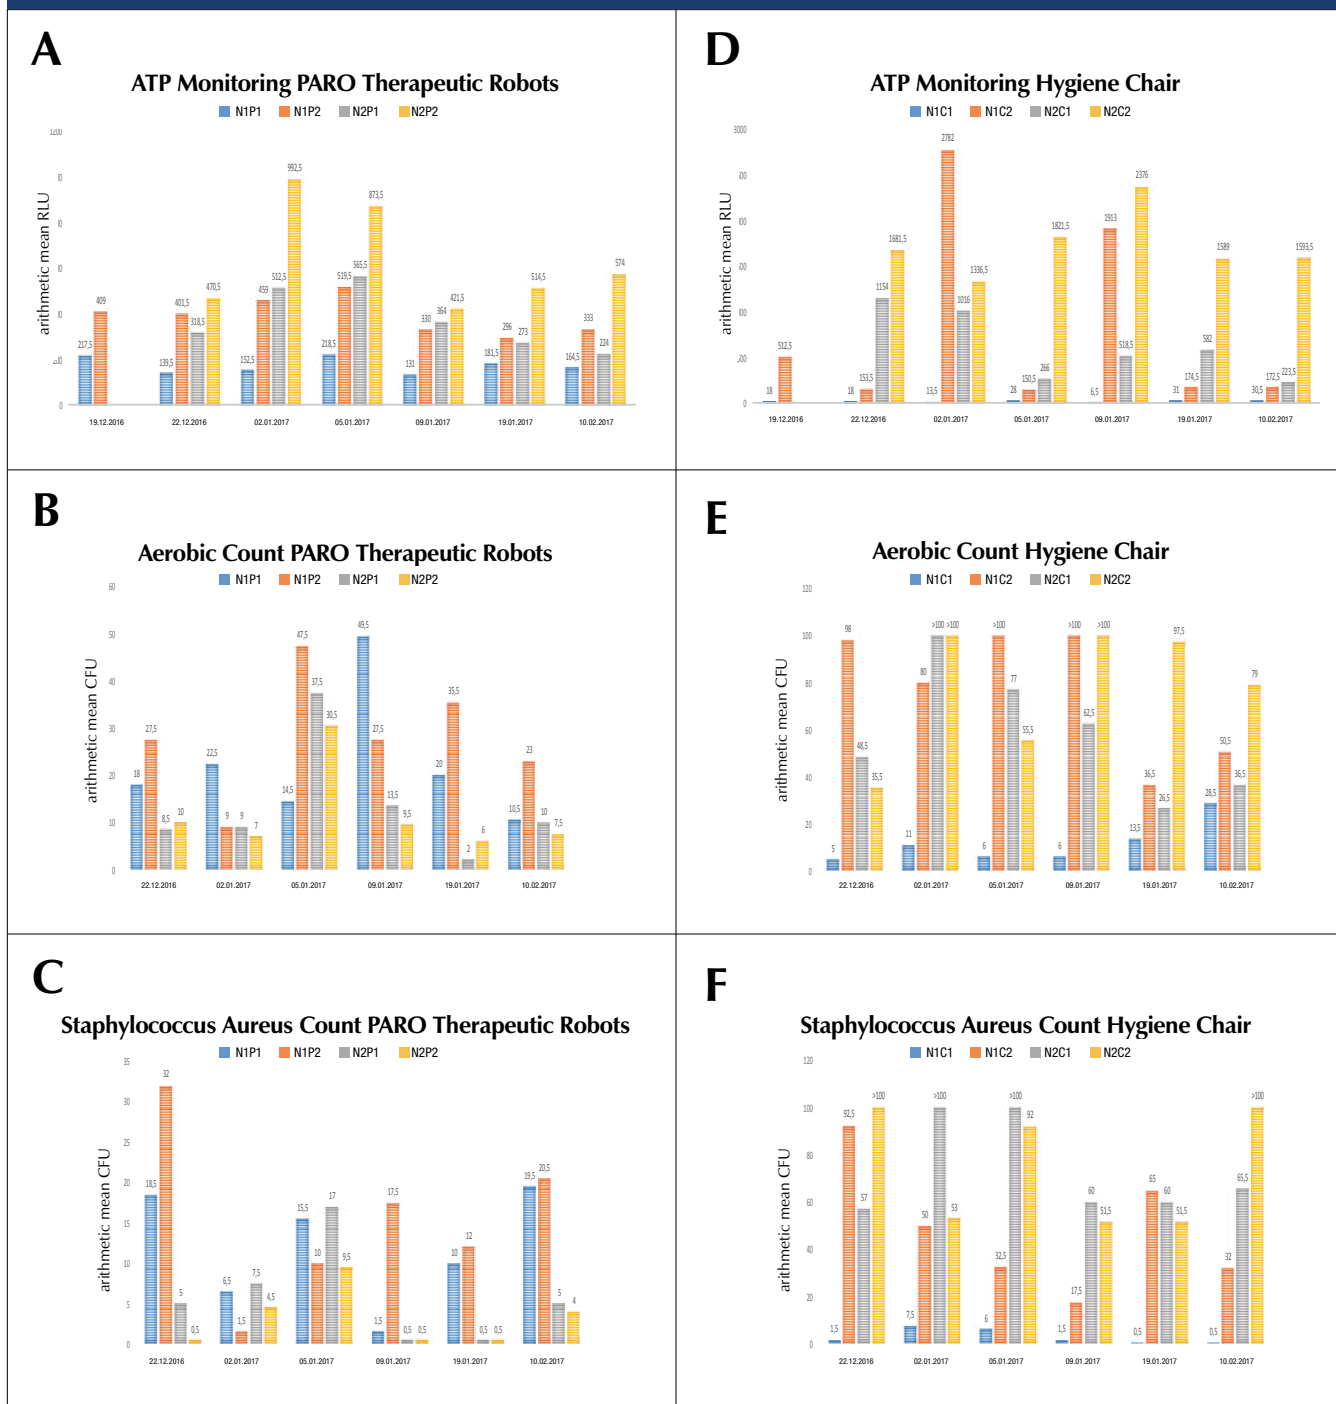
PARO robots N1P1 and N1P2 were not in daily use, which could explain the lower arithmetic mean relative light units (RLU) values, i.e., luciferase activity, compared to the frequently used N2P1 and N2P2 (Figure 3, a). By contrast, N1P1 and N1P2 gave higher arithmetic mean CFU for both aerobic (Fig. 3, b) and *Staphylococcus aureus* counts (Fig. 3, c).

The hygiene chair N1C1 was not in use at the time of testing which may explain the results of the ATP monitoring. However the aerobic count had an arithmetic mean CFU/ml up to 28.5 (Fig. 3). All other Hygiene chairs were sampled after standard cleaning. These showed both a high aerobic count (Fig. 3, e), as well as a higher degree of contamination with *Staphylococcus aureus* (Fig. 3, f). Furthermore, the ATP monitoring (Fig. 3, d) revealed that biological contamination in nursing home two was higher overall than in nursing home one. One Rida®Count sampling of N2C1 gave typical colonies for MRSA on the MRSASelect™ agar. The latter was, however, not validated by other methods. Coliform bacteria (Table 1) were found on all four robots. N1P1 tested positive for *Enterobacteriaceae* at one sampling (Table 1, N1P1).

FIGURE 3: Serial measurements (mean values) of ATP (a,d), aerobic counts (b,e) and *Staphylococcus aureus* counts (c,f) for PARO robots (a,b,c) and hygiene chairs (d,e,f).

PARO robots are often used by several residents and shared between different nursing home sections. It is difficult to clean the artificial fur; it can only be removed and washed by the distributor. However, based on ATP monitoring and aerobic count (Fig. 3, a and b) it seems that bacteria do not long remain viable on the PARO. Nevertheless, it seems also that the PARO robot may be a beneficial environment for *Staphylococcus aureus* (Fig. 3, c). Further studies are needed to confirm this.

The hygiene chairs showed a high level of bacterial contamination, even after standard cleaning. Interestingly, N1C1 which was not in use showed an increase in the aerobic count. This may indicate that the rough surface structure of the hygiene chairs may accumulate airborne bacteria. In general, this study has shown that current cleaning procedures for hygiene chairs are not adequate. One of the chairs in this study, N1C2, used by several residents, tested positive for cefotaxim-resistant *P. fulva* and *P. putida*.
